# Structural Forensic Engineering Case Study : MRR2 Project

Prof. Dr. Azlan Abdul Rahman  
Forensic Engineering  
Universiti Teknologi Malaysia

## MRR2 MAIN FLYOVER IN KEPONG

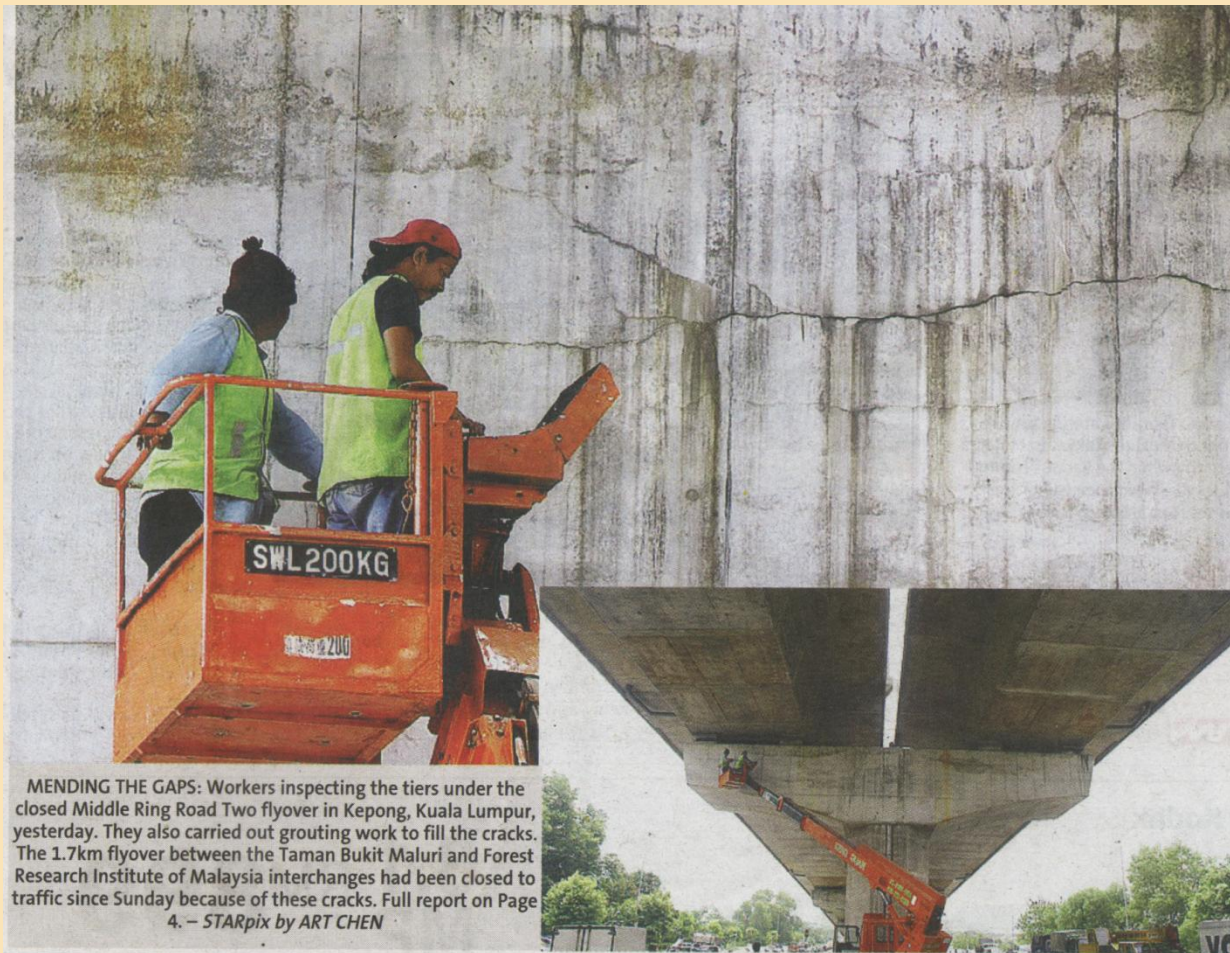
# The Observed Cracks

Discovery of 33 hairline cracks

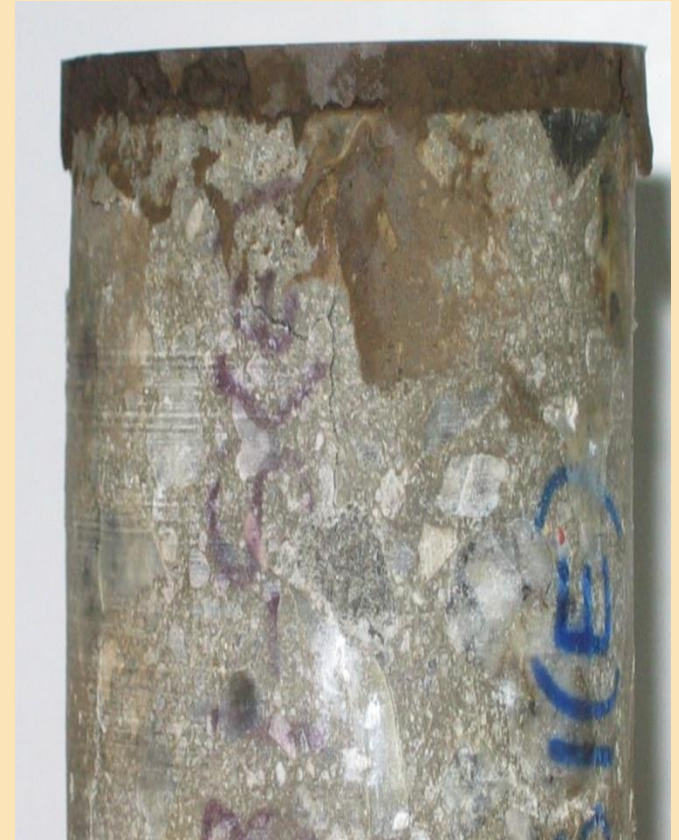
Failure mode of core  
observed after test

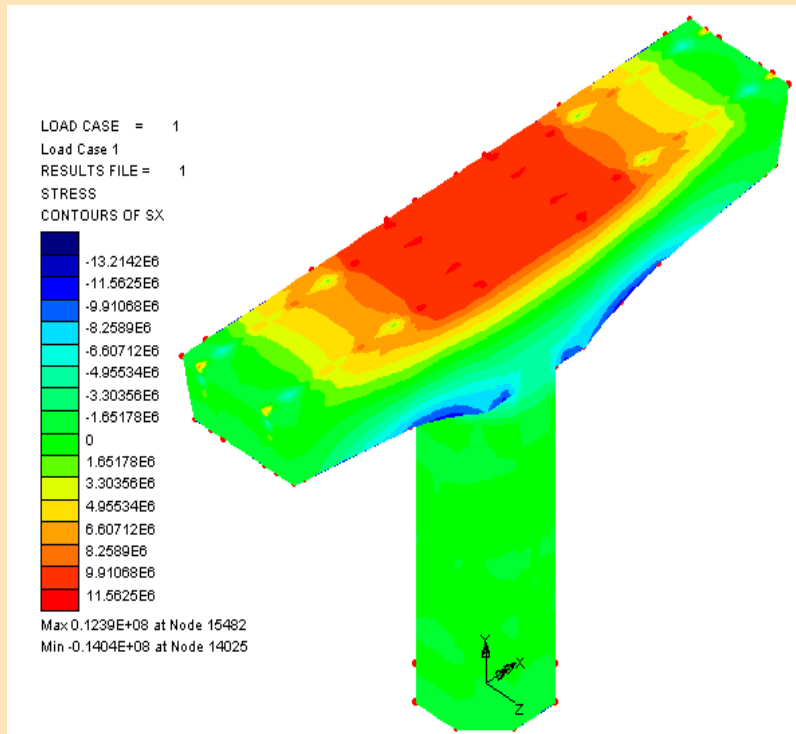
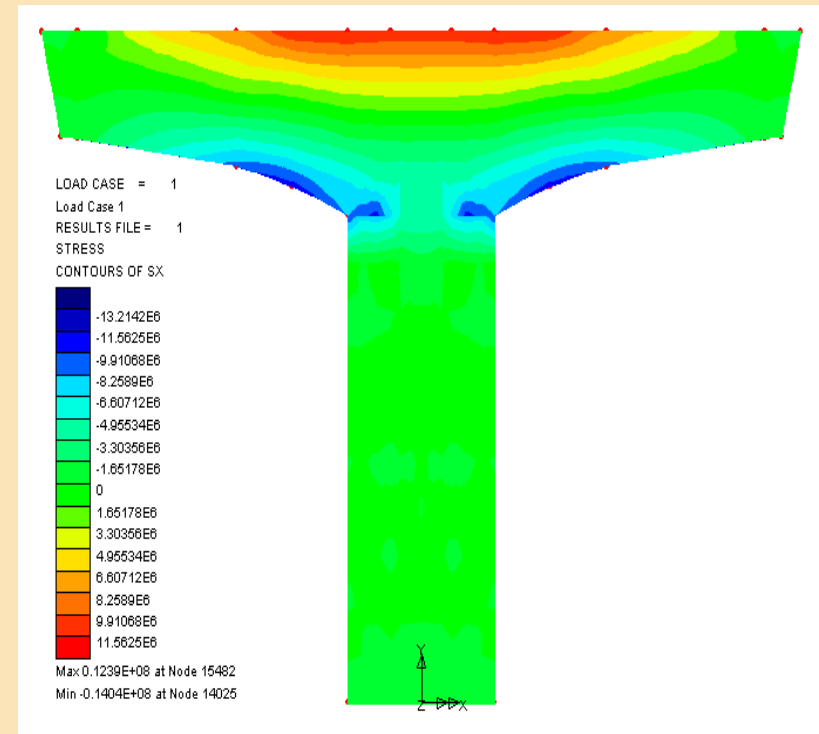
# Longitudinal Stresses

Number of longitudinal bars are adequate. Design is OK for longitudinal direction.

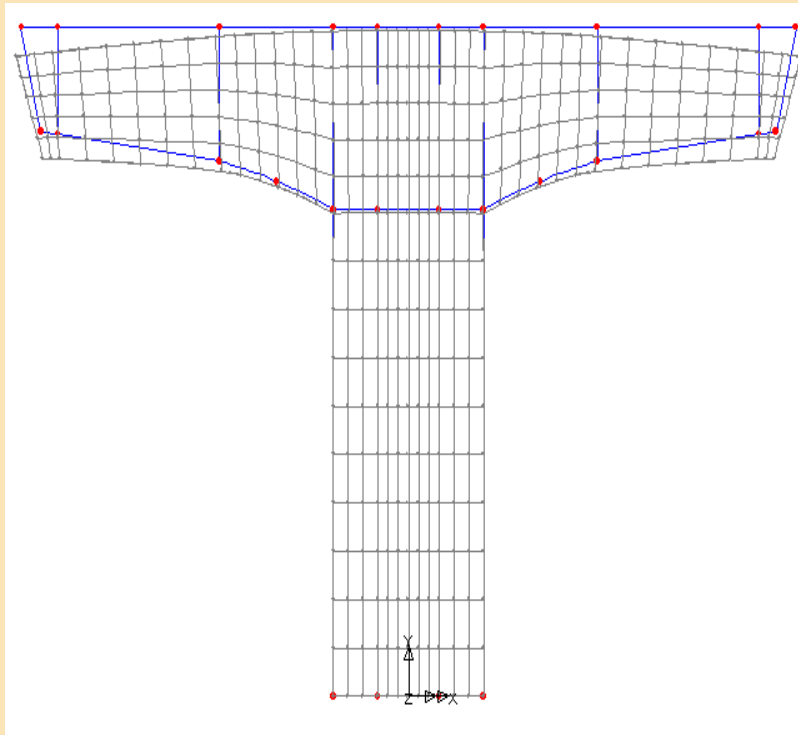
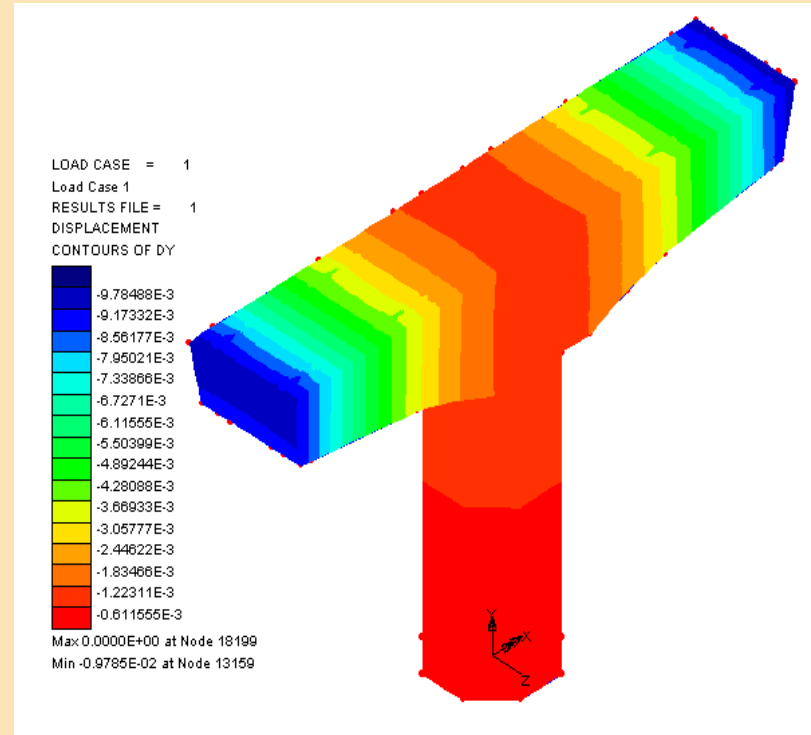
# Deformed Shape of Pier

**Deflection check is OK**

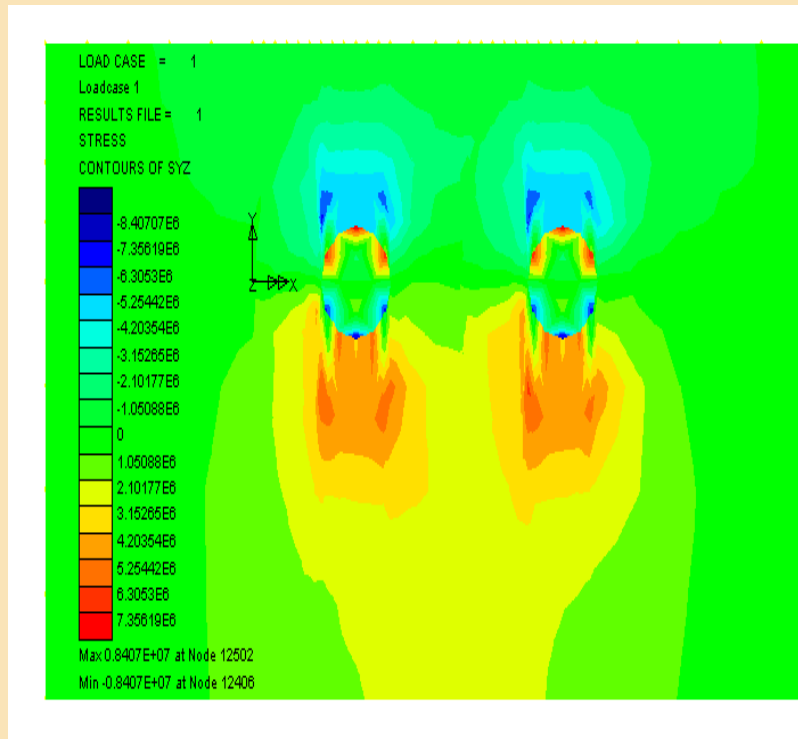
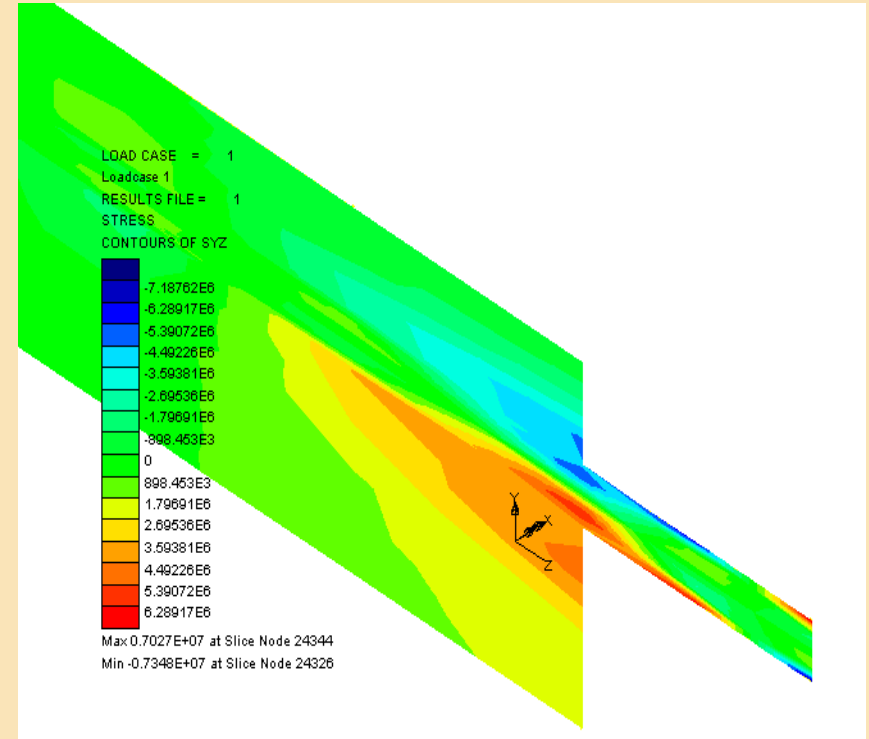
# Shear Stress Contours

Bonding stresses (Front view and along vertical section)  $\sim 4$  to  $5 \text{ N/mm}^2$  is greater than the allowable bonding stress of  $3$  to  $3.53 \text{ N/mm}^2$

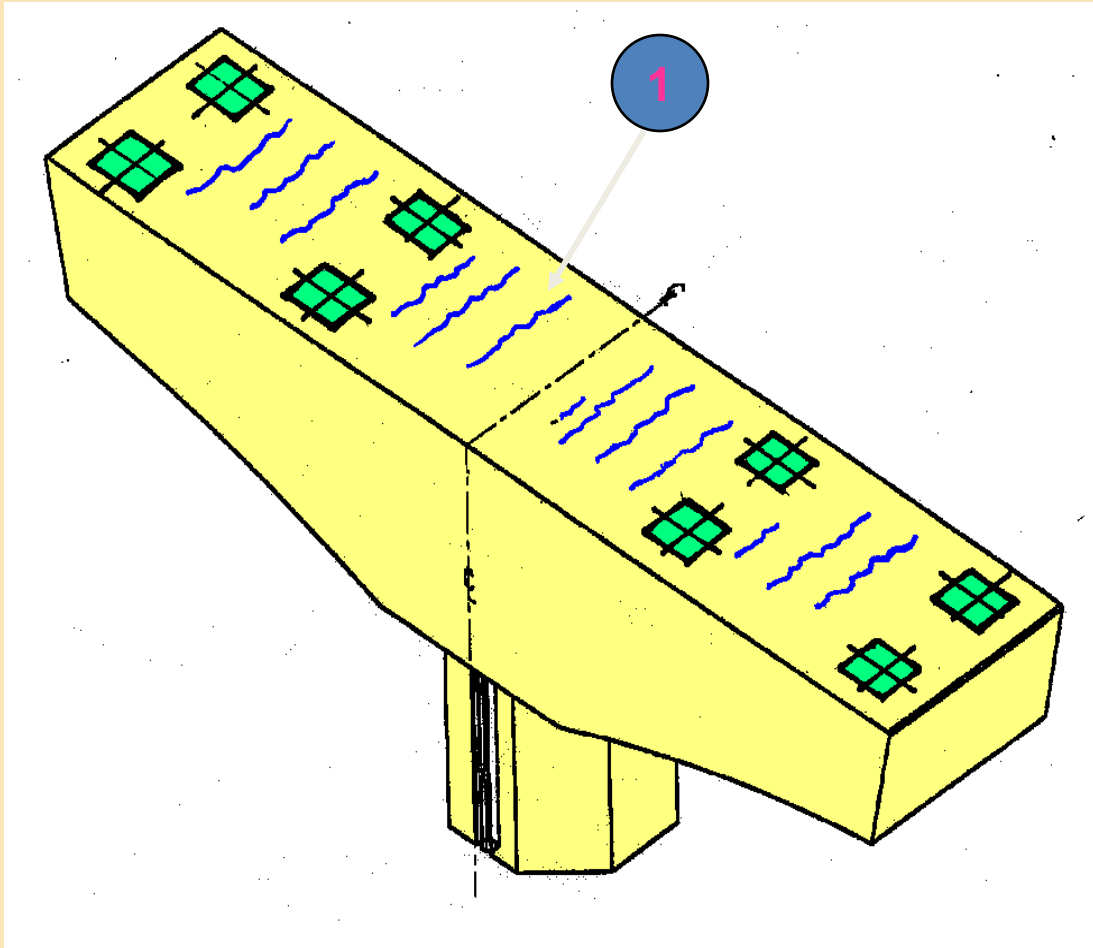
# Type 1 Cracking

- Non-structural cracks due to early thermal expansion
- Occurred after striking of formwork
- Dead load due to self-weight only
- Insufficient curing and hence cracking is possible if the formwork was struck too early – no evidence to ascertain this

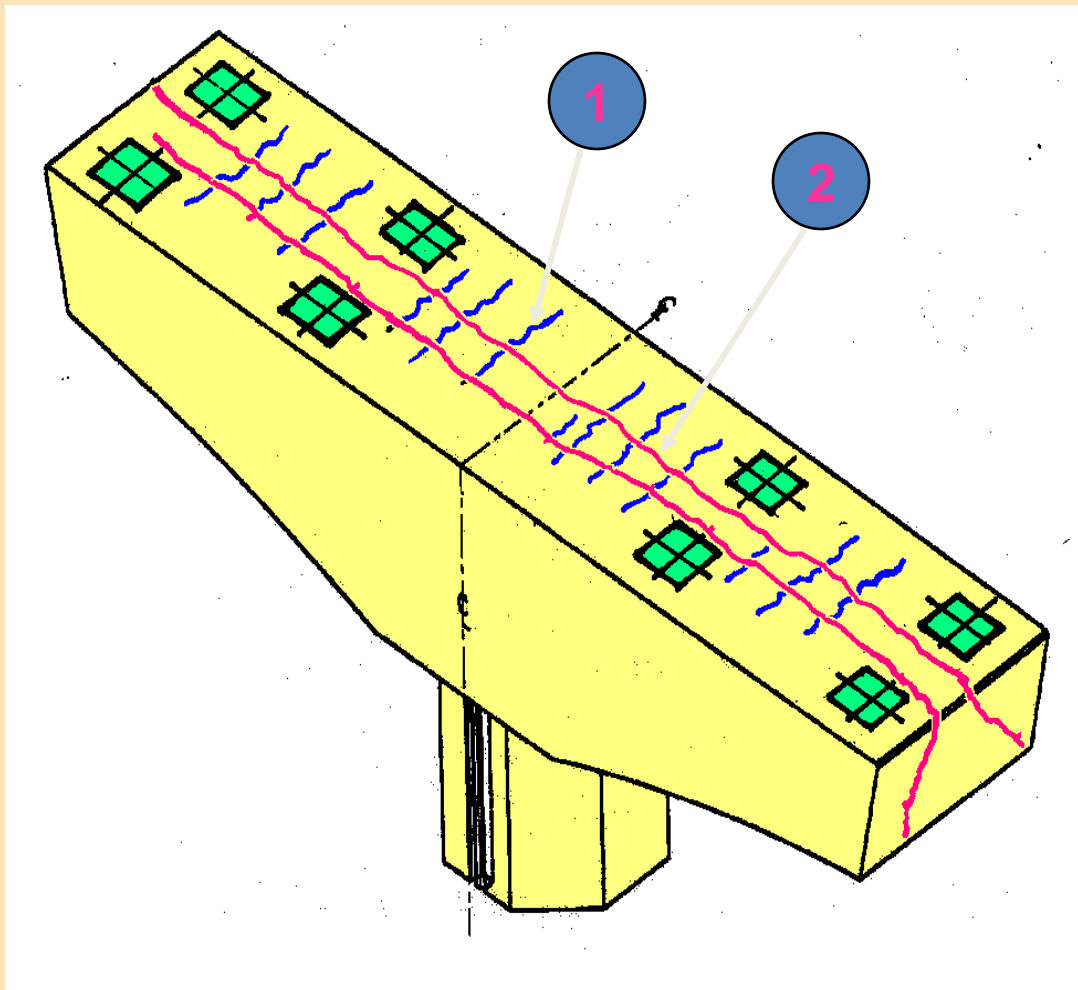
# Type 2 Cracking

- Structural cracks – splitting of concrete.
- Inadequate transverse steel to take up tension.
- Cannot take up dead load (SW) plus crane during erection.
- No design calculations for transverse tensile force consideration.
- Factor of safety based on transverse tension is less than 1.

- Alternative design did not provide adequate transverse steel in the crosshead;
- Alternative design T16@175mm (replaced T20@150mm in the original design) was inadequate in resisting tension in the crosshead.
- This failure to take up transverse tension had caused splitting during erection of the box girders.
- The design calculations should have taken into account all loads including the crane loads during erection.
- The calculations for transverse steel in the alternative design and the consultant's assessment of the cracks were grossly missing.

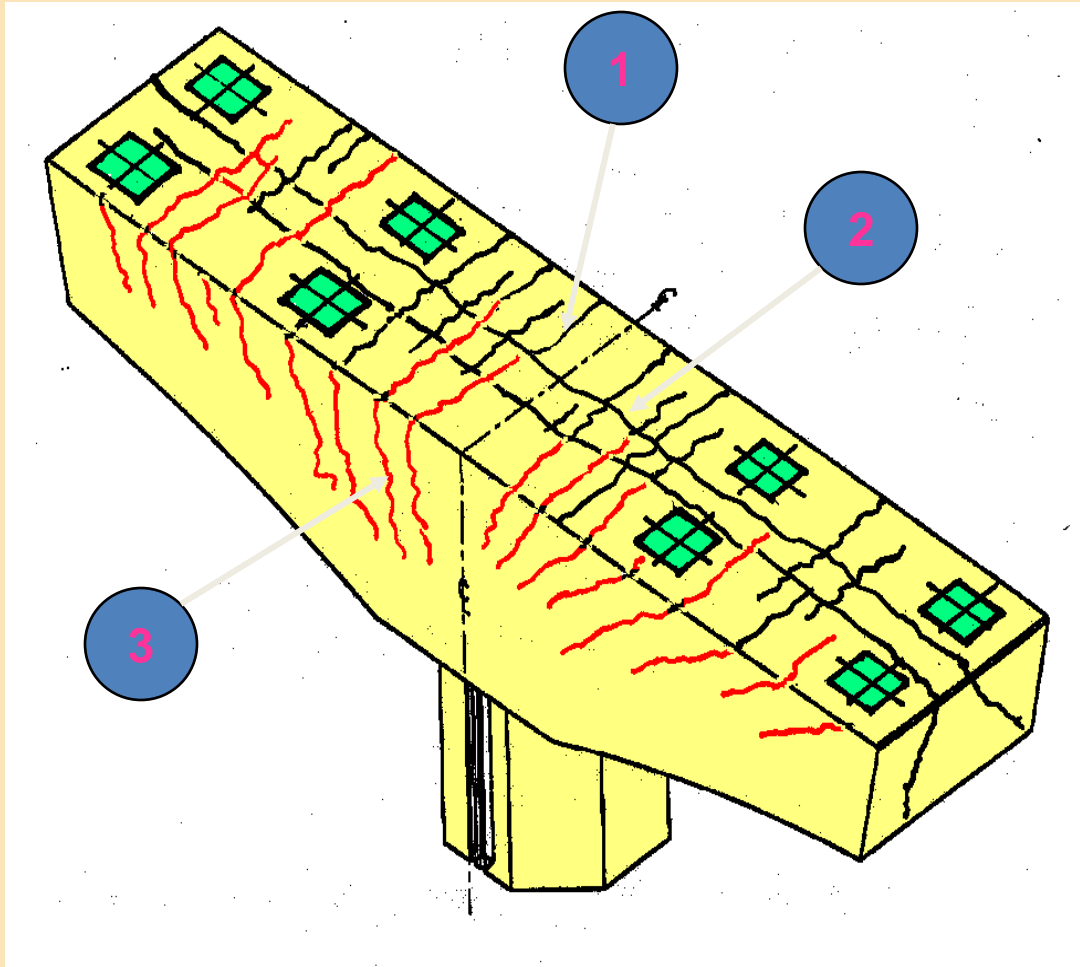
# Type 3 Cracking

- Structural bending cracks due to reduced effective width and lack of bonding
- Bonding failure due to lack of bonding in lap at the mid-region of crosshead
- Cannot take up dead load plus crane load due to combined effect of bonding and splitting.
- Factor of safety for longitudinal moment is less than 1.

- Location of lap for longitudinal bars in the mid-region of crosshead was not appropriate as it caused congestion of reinforcement – spacing of about 50mm between bars could not provide sufficient concrete for bonding.
- This had caused bonding failure even when the material quality and strength was adequate.
- Details in original design provided sufficient spacing between longitudinal steel (120mm) and there was no lap in the middle region of crosshead.

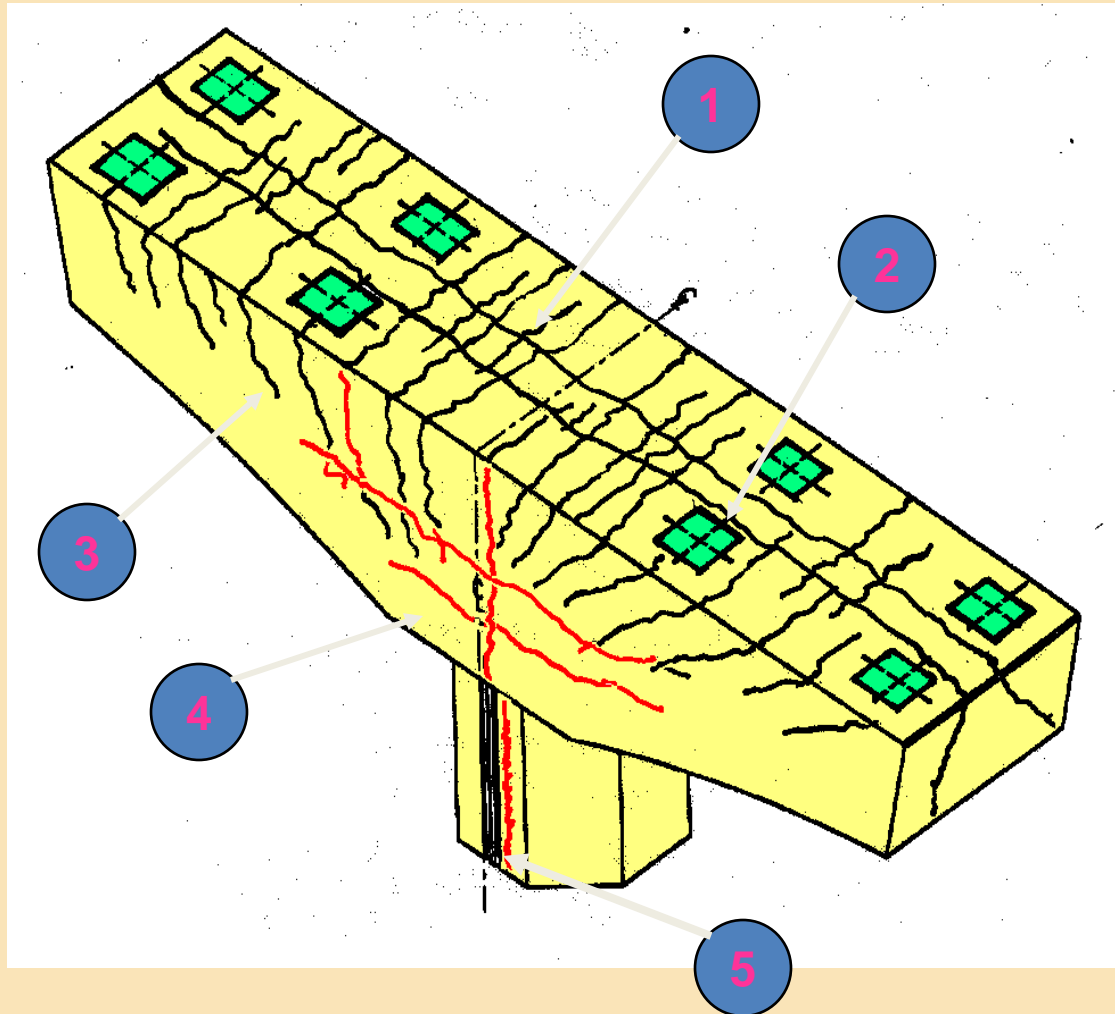
# Type 4 & 5 Cracking

- Longitudinal cracks on the face of crosshead.
- New cracks propagated as the steel yielded.
- Vertical crack in pier stem initiated by tensile force at top of stem (see finite element modeling)
