Collapse of 2000 Commonwealth Avenue

Suzanne King,
Roger Williams University
Faculty Advisor: Dr. Norbert Delatte

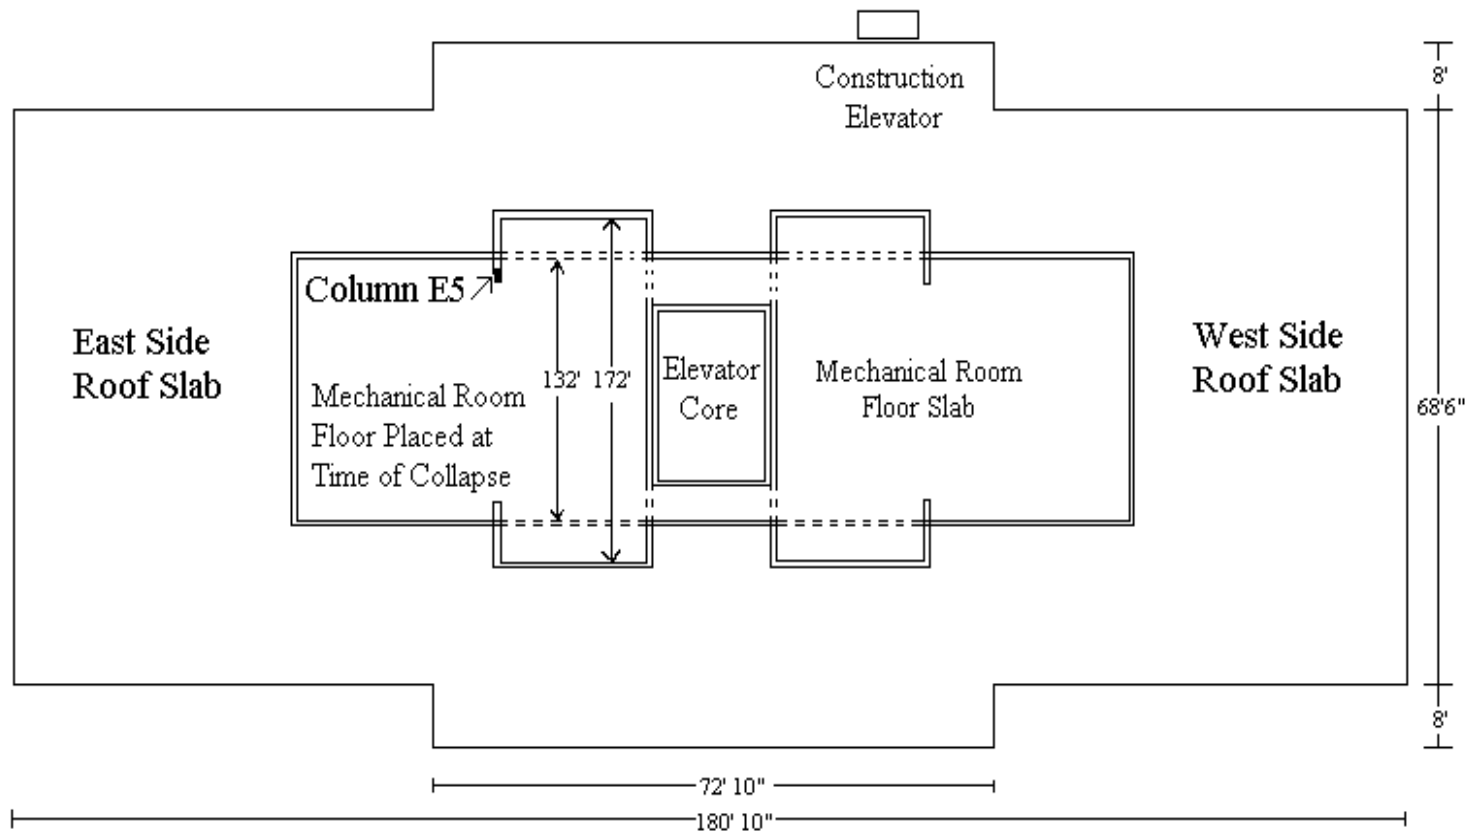
Floor Plan

- About 3:00pm workers take break from placing concrete for the mechanical room floor slab
- Placement started at the west edge and proceeded east
- Shortly after break there was a drop in the floor slab
- Punching shear was noticed around column E5

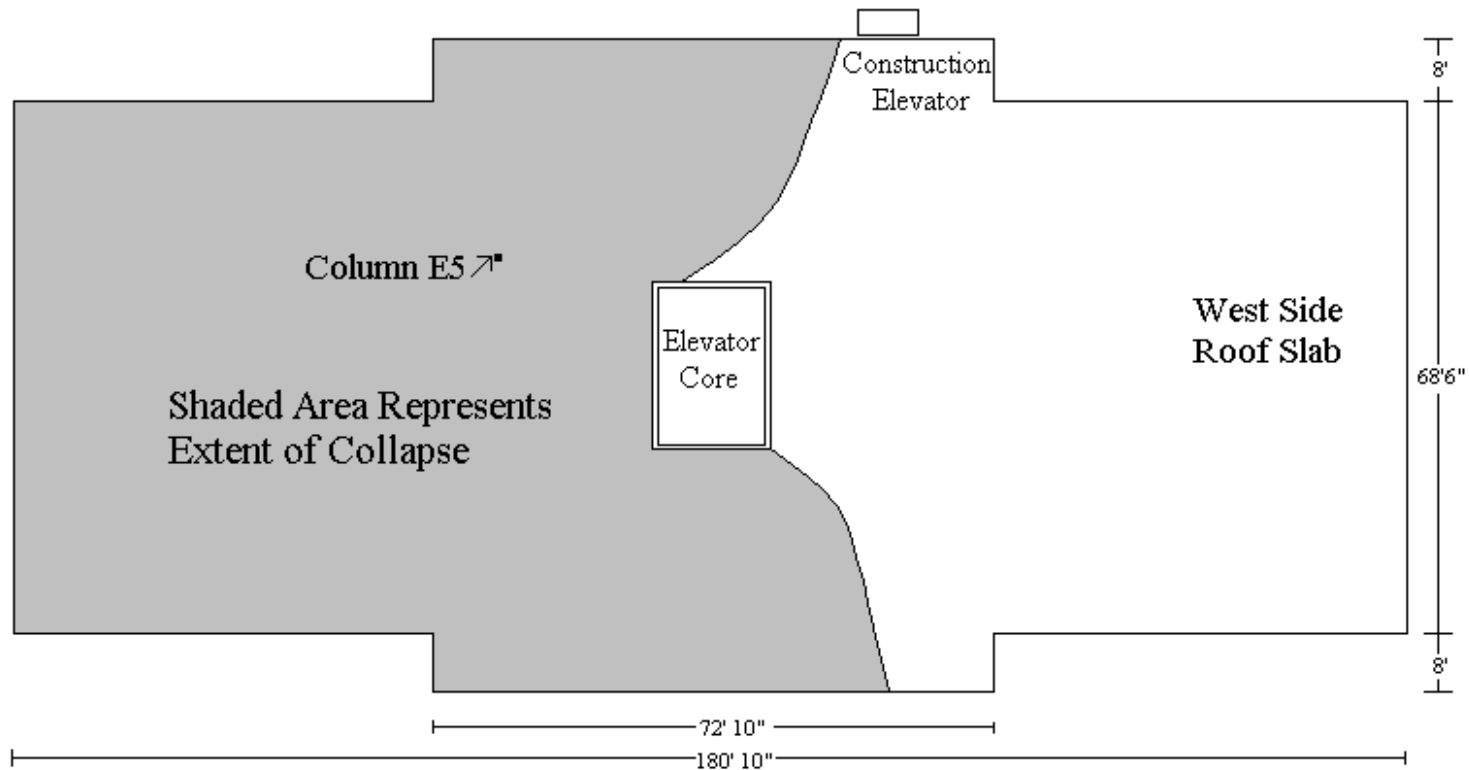
Extent of Collapse

- Progressive collapse occurred 20 minutes after roof collapsed
- Weight of the roof caused the 16th floor to collapse onto 15th and so on down to the ground
- Two thirds of the building was gone
- Four workers died

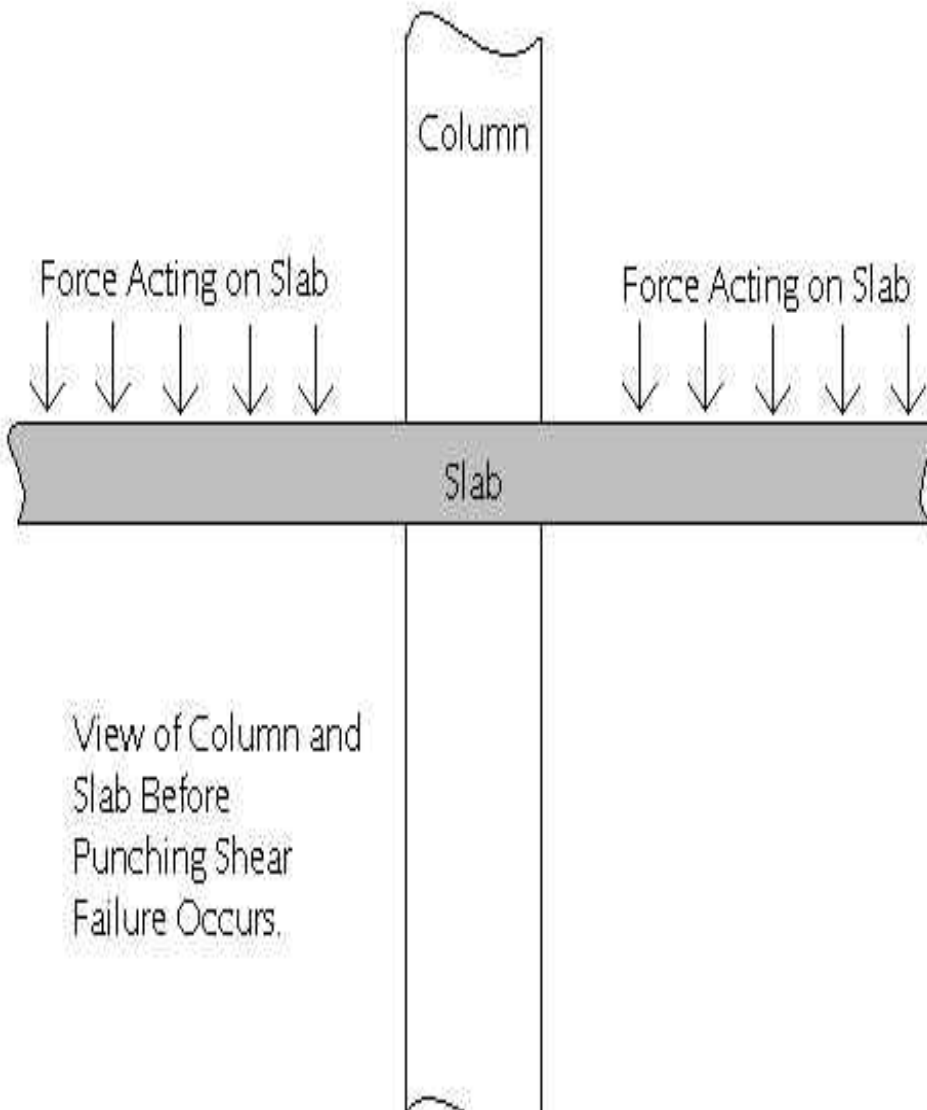
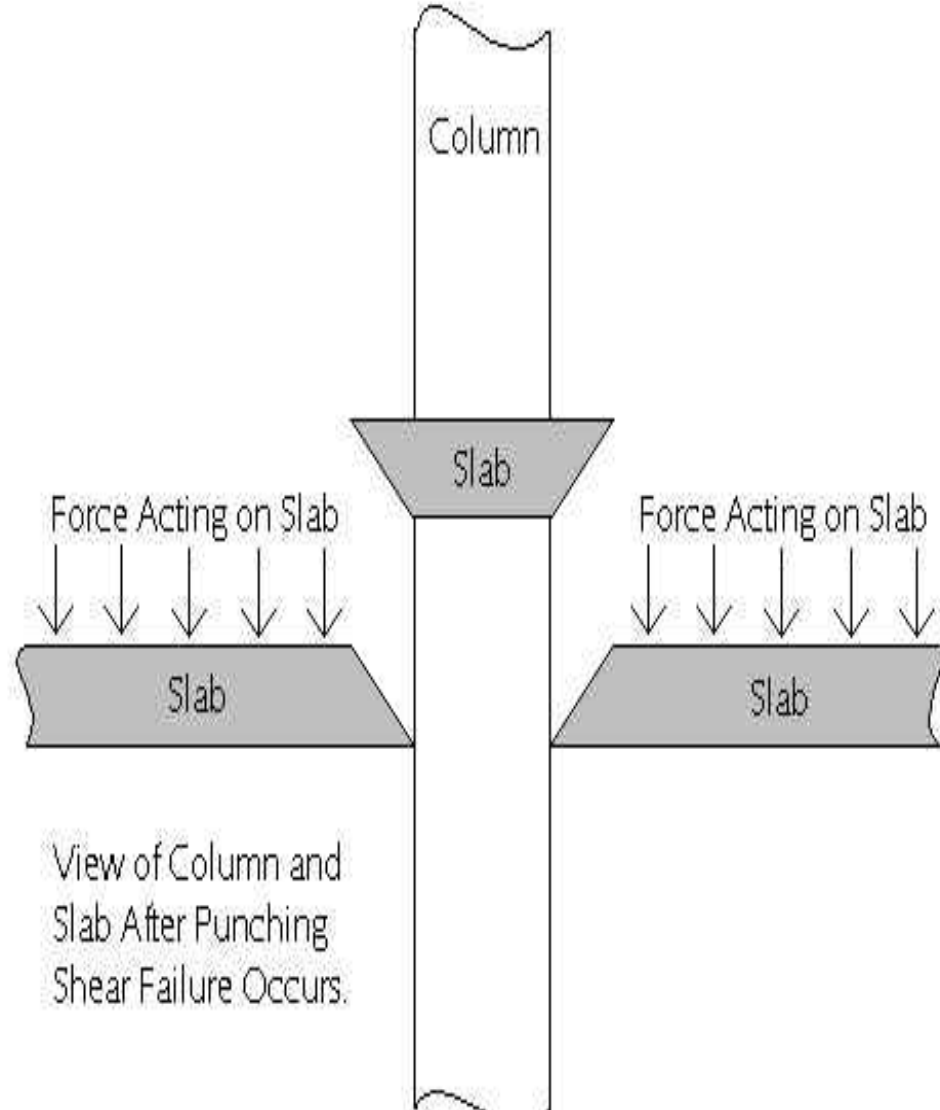
Punching Shear

- Happens when floor slab becomes too great for a column to hold
- Added construction loads can cause unbalanced moments
- The dead weight the column cannot hold is transferred to surrounding columns. However, this added weight is often too great and the floor slab fails.

- Concrete strength was well below required 3000 psi
- Inadequate shoring under the roof slab
- Construction equipment and two boilers were on the roof
