Overview of Forensic Engineering

Prof. Dr. Azlan Ab. Rahman
Forensic Engineering
Faculty of Civil Engineering
Universiti Teknologi Malaysia

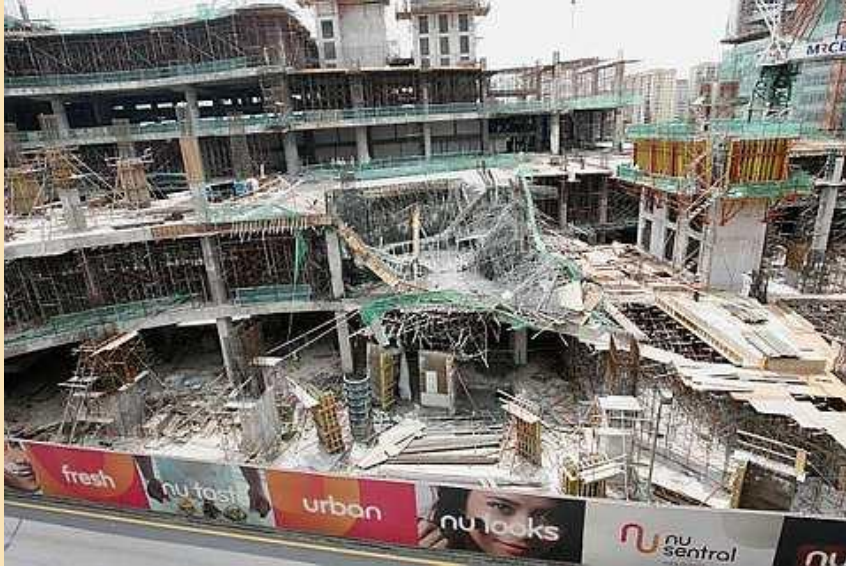
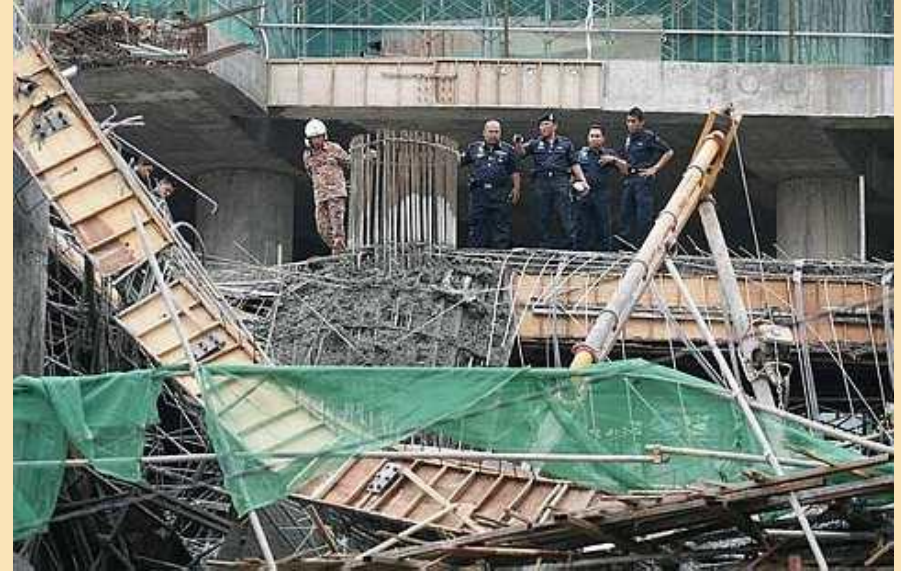
Floor Slab Collapse

Collapse of third floor slab under construction at KL Central.
Tuesday 11am, October 11th, 2011. Two workers injured.

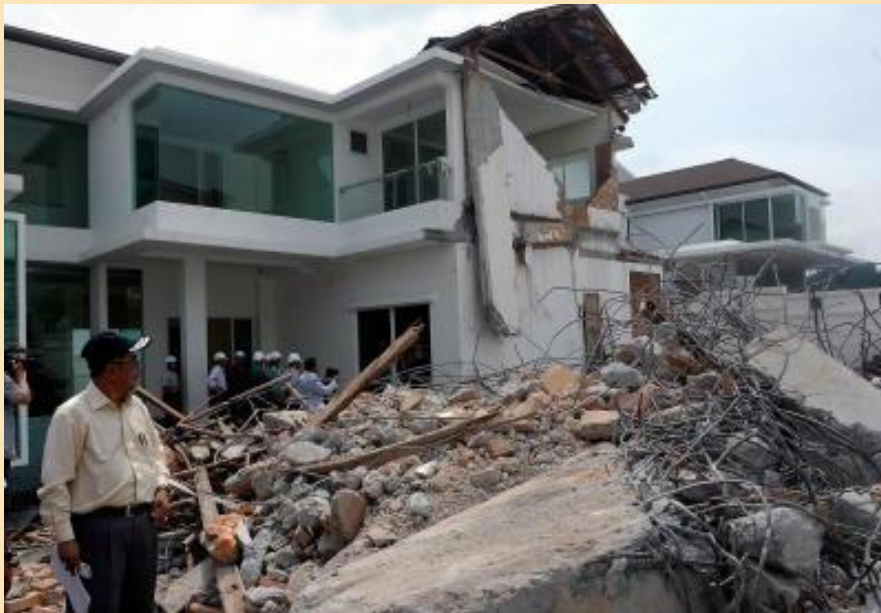
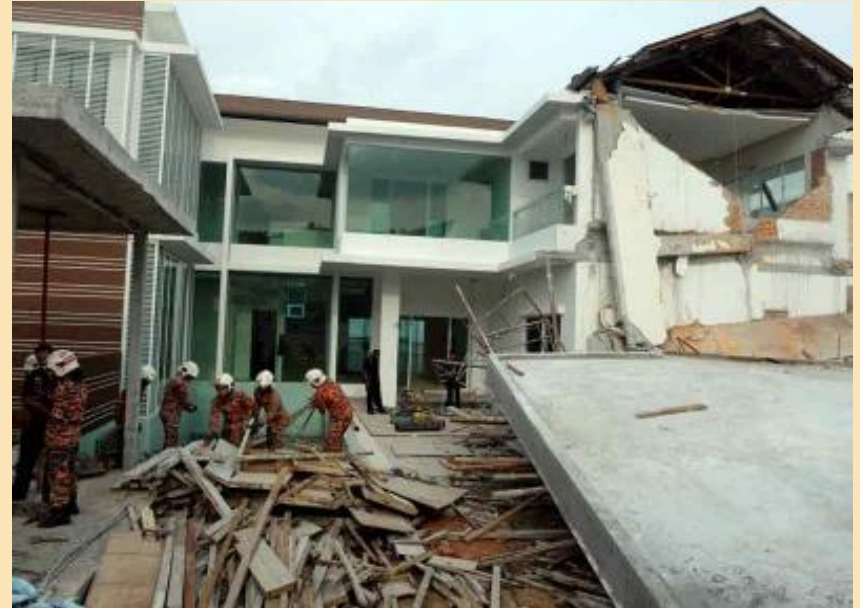
Bungalow Renovation Work

October 19th, 2012. Section 7, Shah Alam. One worker died and 5 critically injured when the concrete slab collapsed. The owner is facing the risk of legal action for not having the renovation permit from Shah Alam City Council as per Section 70(1) of the Akta Parit, Jalan dan Bangunan 1974.

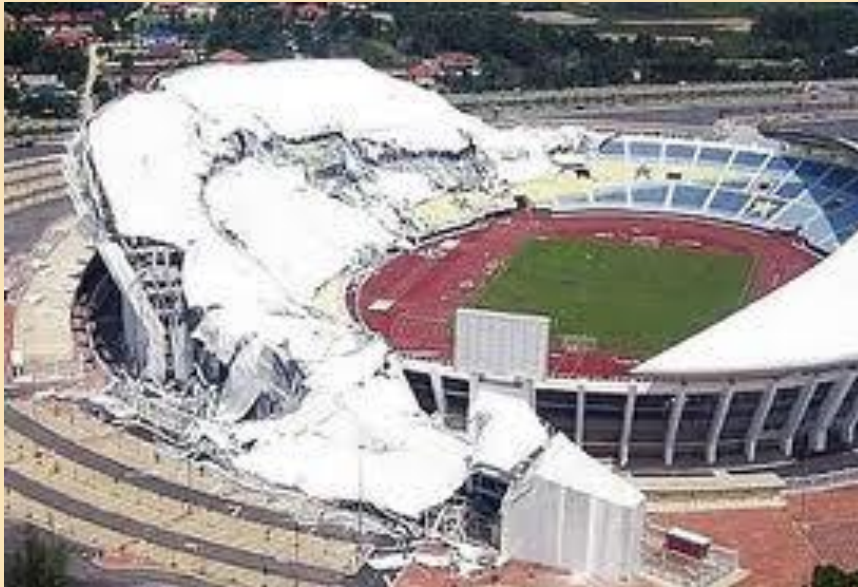
Collapse of Scaffolding in Stadium Repair Work

Collapse of the scaffolding of repair work on the same stadium in 2013, February 20th, 11.30am. Two workers injured (broken legs).

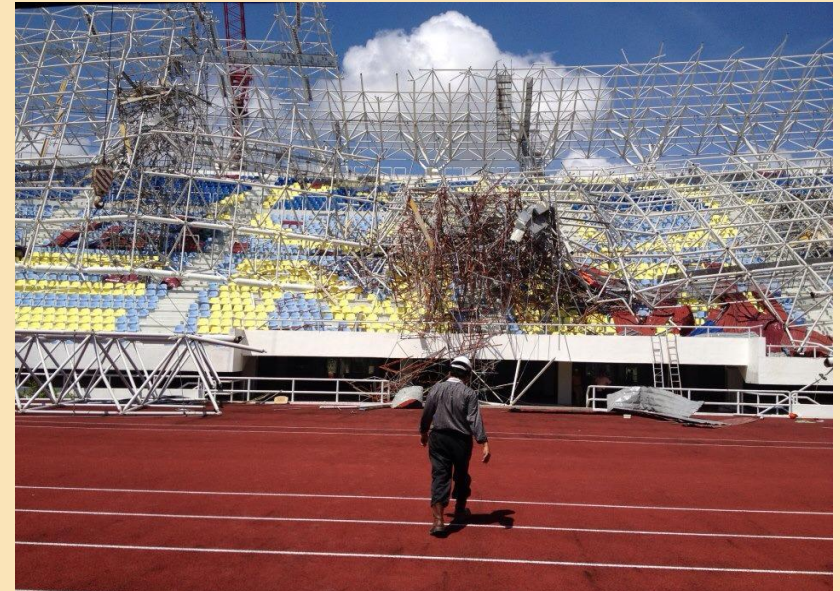
Collapse of Stadium Sultan Mizan, Terengganu in 2008

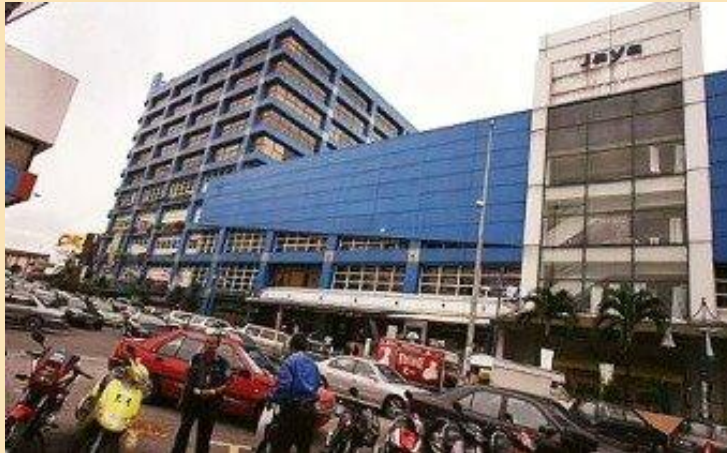
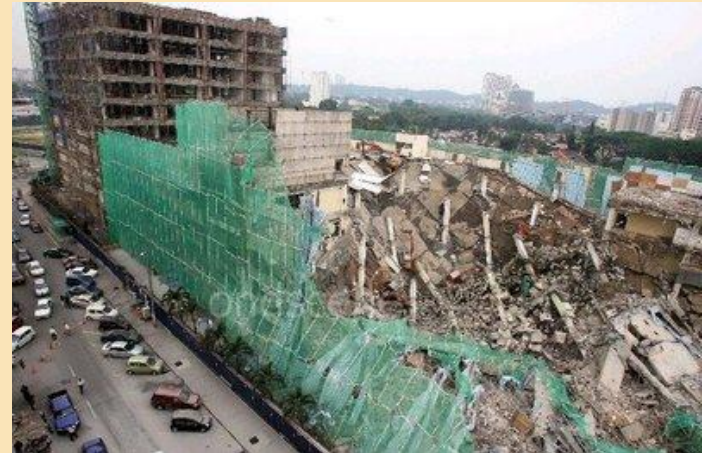
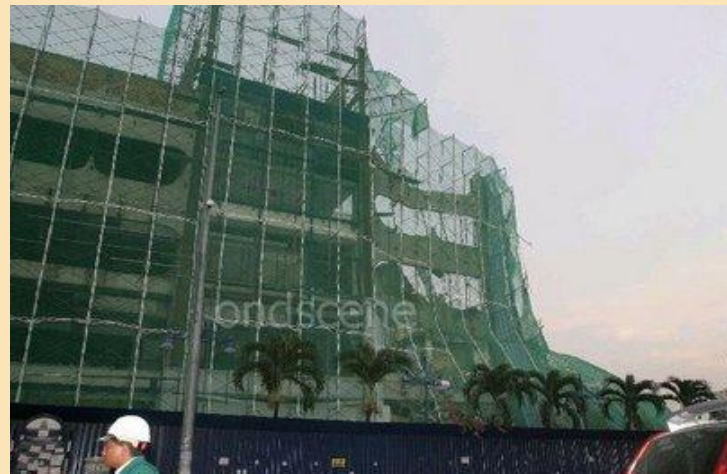
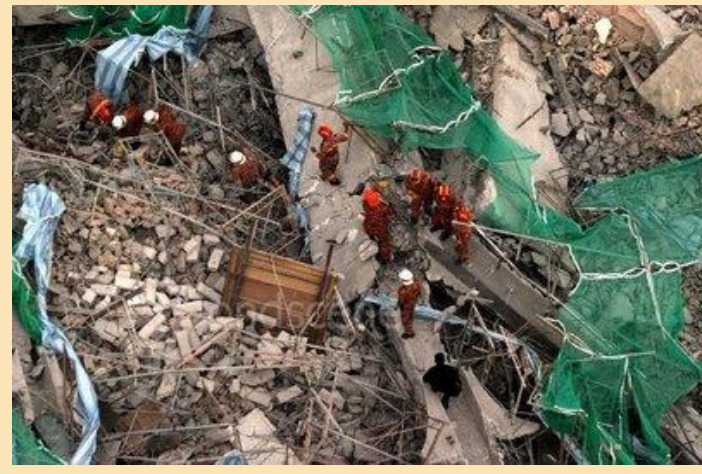
Collapse of Supermarket Upgrading Construction

May 29th, 2009. Collapse of ne-third section of renovation and upgrading work on 35-year old Jaya Supermarket building, Section SS14 PJ. Three workers died and two critically injured.

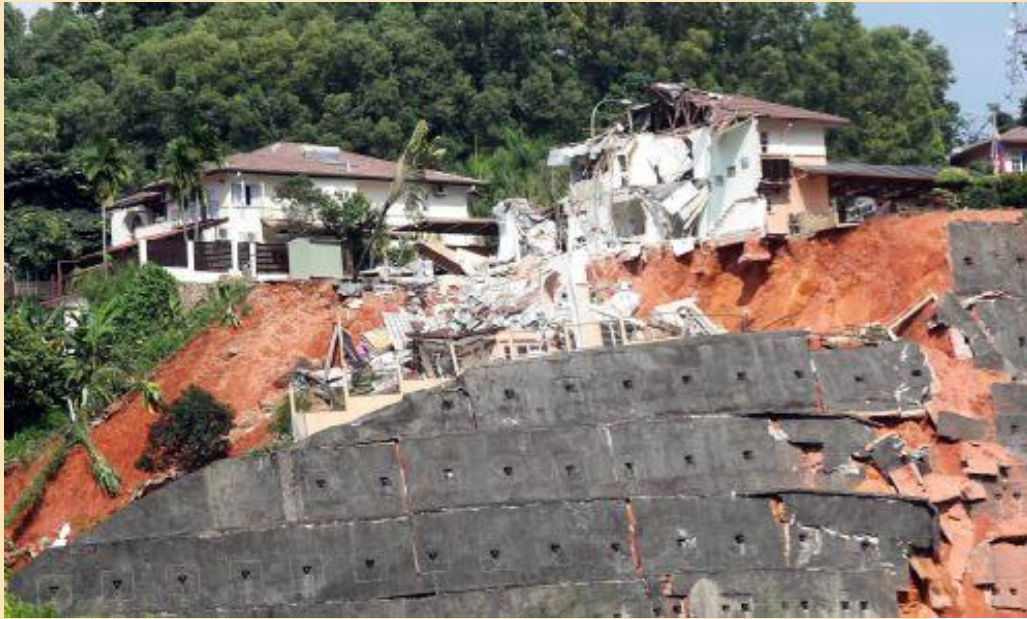
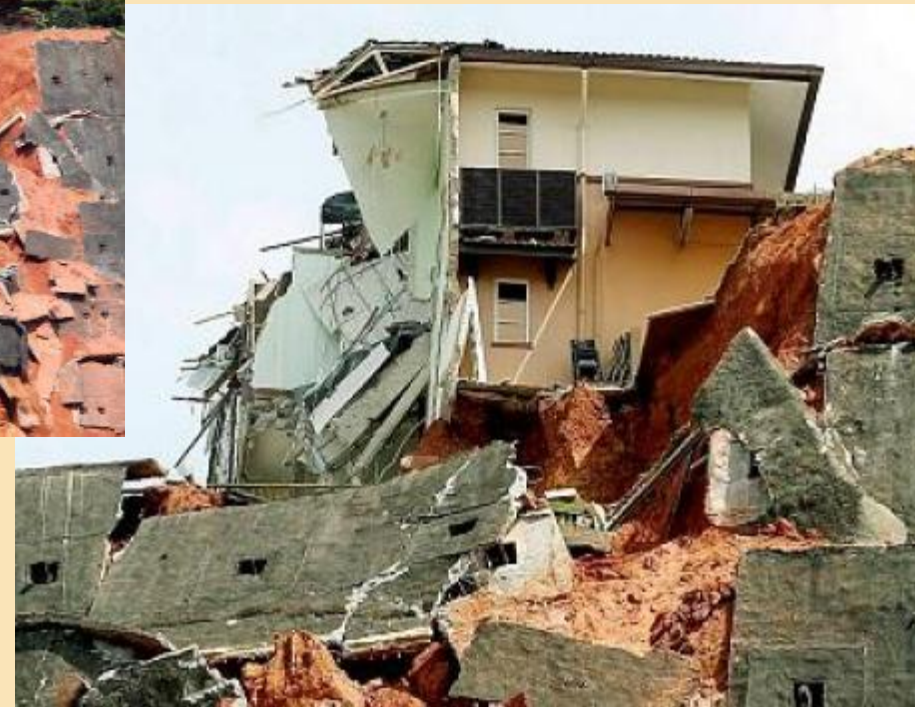
Collapse of Retaining Wall

Setiawangsa land slide forces residents of 88 houses, shoplots to evacuate. One luxury hilltop bungalow was split into two after the 43m retaining wall at Jalan Puncak Setiawangsa 2 collapsed, at 6pm 28th December 2012.

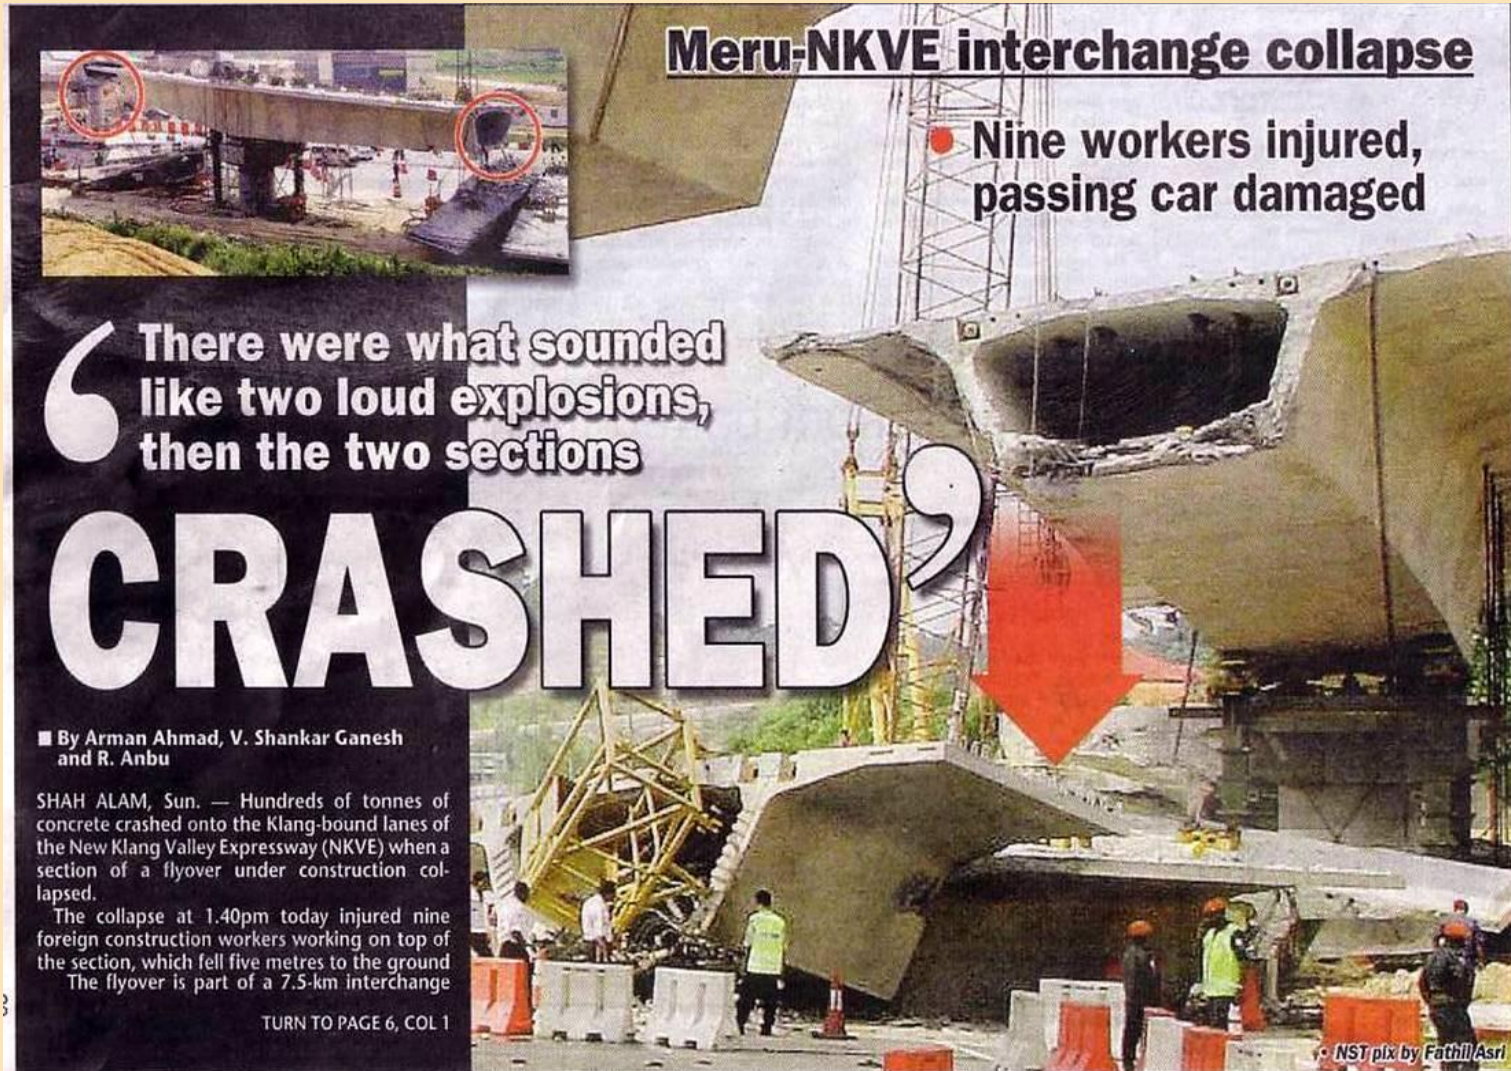
Box Girder Bridge Section Collapse During Construction

SHAH ALAM, Sun. — Hundreds of tonnes of concrete crashed onto the Klang-bound lanes of the New Klang Valley Expressway (NKVE) when a section of a flyover under construction collapsed.

The collapse at 1.40pm today injured nine foreign construction workers working on top of the section, which fell five metres to the ground. The flyover is part of a 7.5-km interchange.

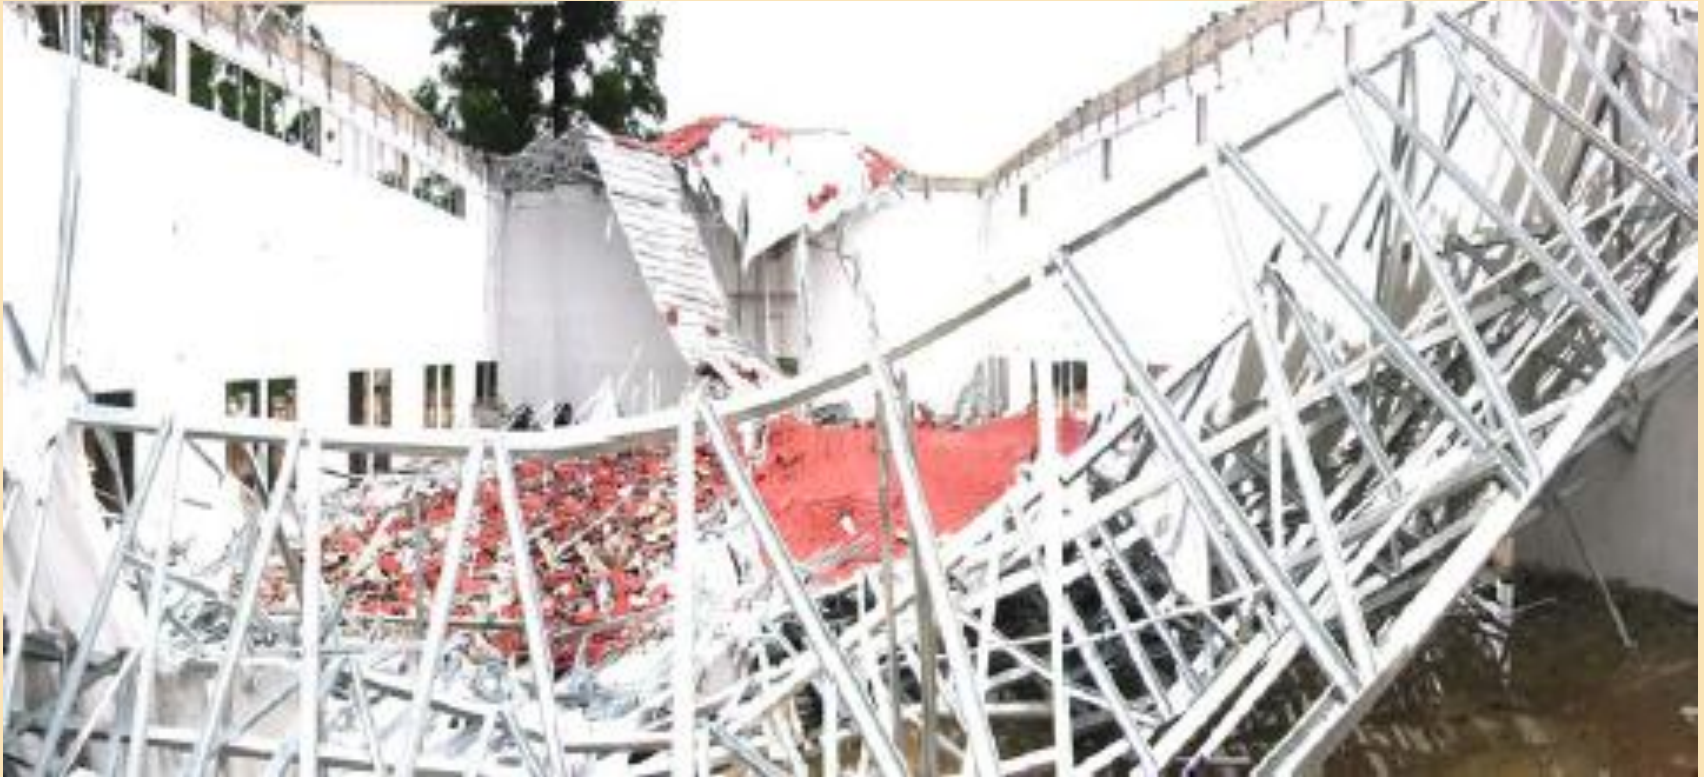
Roof Collapse

8th October 2005, NST: The roof of the multi-purpose hall at Sekolah Menengah Sains Sultan Ahmad Shah in Kuantan collapsed. It is learnt that the supporting aluminium structure and the roof tiles came down at 10pm.

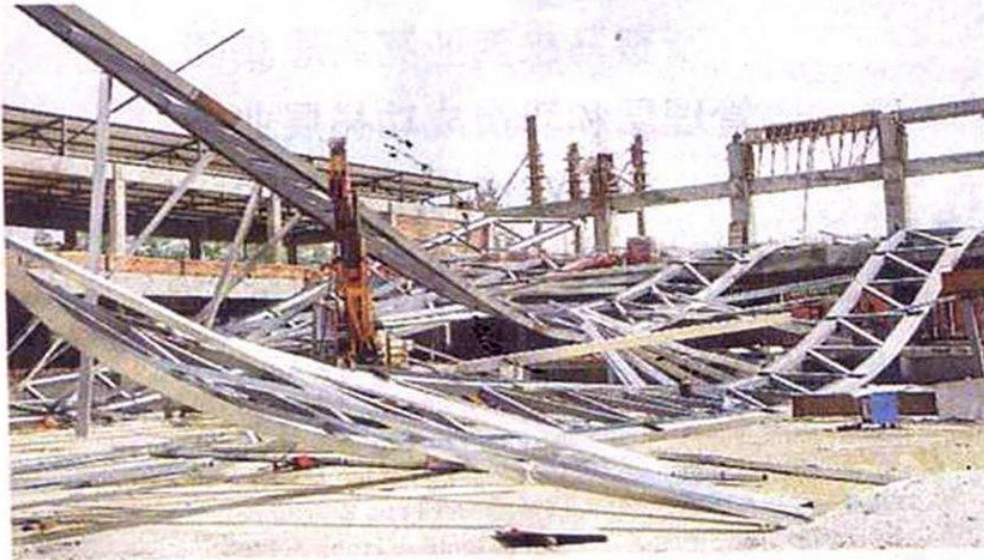
Stadium Roof Collapse

FALLEN ROOF: Indonesian worker Sumaidi was killed when the steel roof structure of the bowling stadium collapsed in Paroi, Negri Sembilan, yesterday.

the steel structure on the upper level of the building when the roof gave way and collapsed.

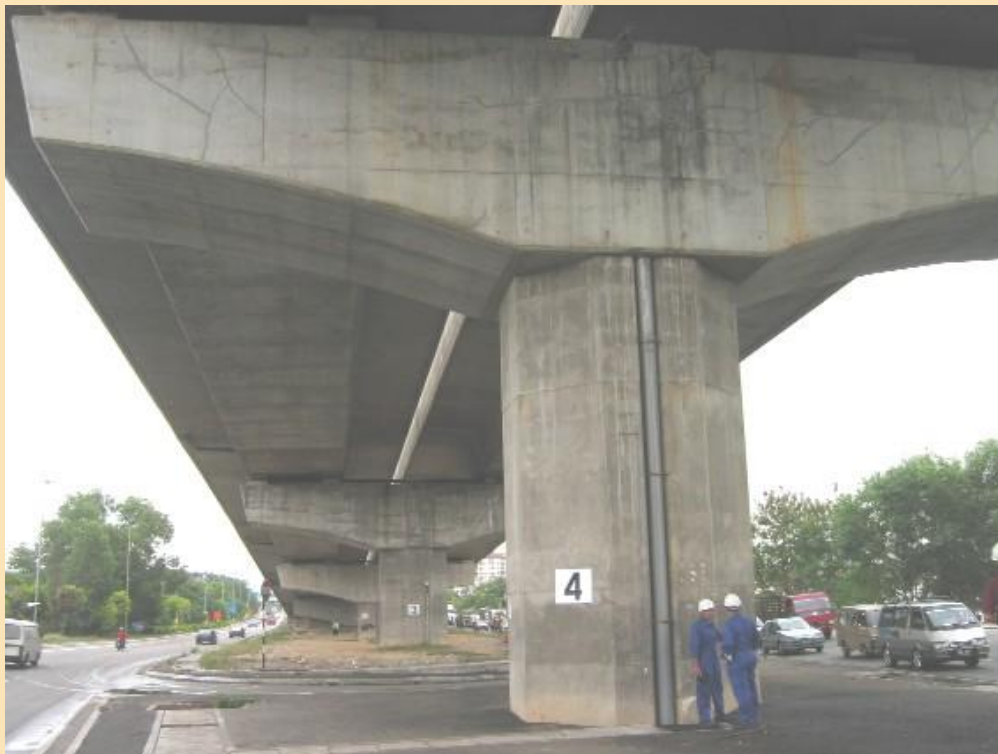
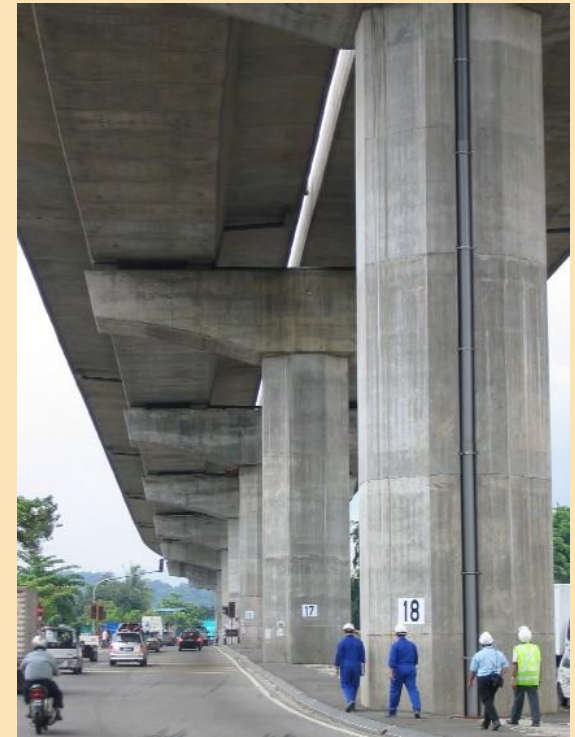
Case Study 1: Extensive Cracks in 33 Pier-Crossheads of an Elevated Bridge

The Works Ministry had on Aug 9, 2004 ordered the 1.7km flyover to be closed to traffic after experts found it to be a threat to public safety.

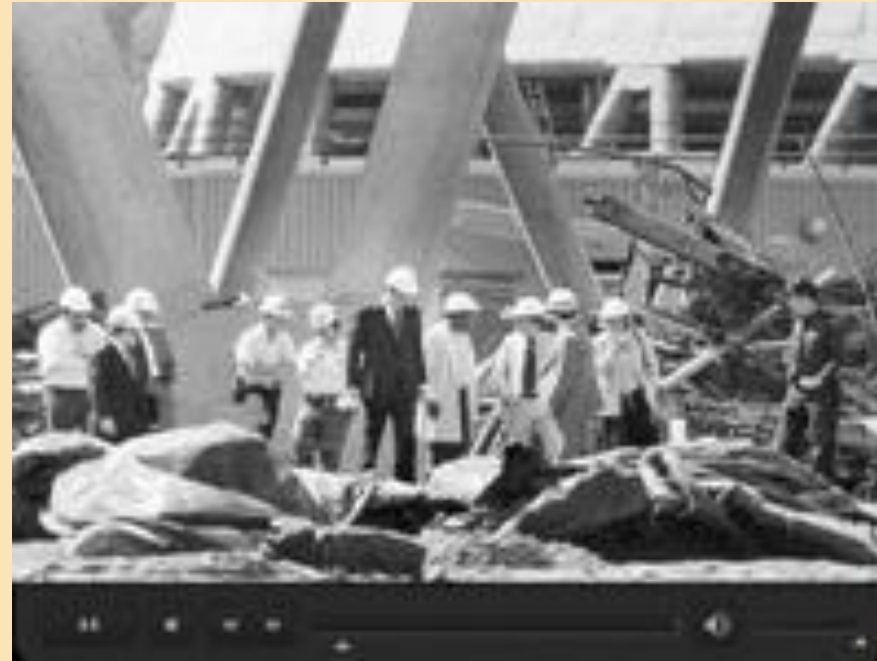
Willow Island Cooling Tower Collapse (USA)

Collapse occurred on April 27, 1978, 10:00 a.m. Top portion of the concrete shell collapsed inward. Scaffolding and working platforms also collapsed. All 51 workers were killed.

- On-Site Investigation
 - Interviews; Laboratory Tests; Computer Analyses
- Inadequate Strength of Lift 28 on Concrete Shell to resist Construction Loads
- Sanctions
 - Tower Designer-Contractor
 - General Contractor
 - Testing Laboratories
- Legal Actions
 - Civil Suits & Criminal Charges

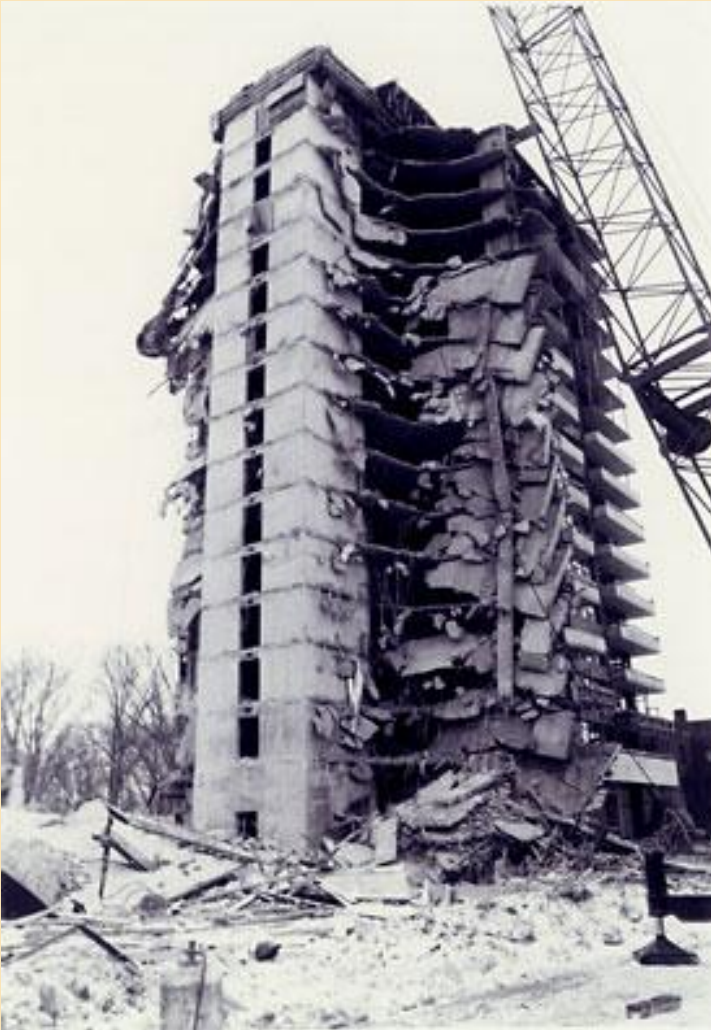
Collapse of Commonwealth Avenue Building Boston

The collapse of 17-story concrete high-rise under construction at 2000 Commonwealth Avenue, Boston, occurred on January 25, 1971. Many factors contributed to the collapse and can be seen in 3 phases:

- Phase 1: Punching Shear Failure in the Main Roof at Column E5
- Phase 2: Collapse of Roof Slab
- Phase 3: General Collapse

- Concrete strength was well below required 3000 psi
- Inadequate shoring under the roof slab
- Construction equipment and two boilers were on the roof
