# Structural Forensic Engineering Case Study : MRR2 Project

Prof. Dr. Azlan Abdul Rahman  
Forensic Engineering  
Universiti Teknologi Malaysia

## MRR2 MAIN FLYOVER IN KEPONG

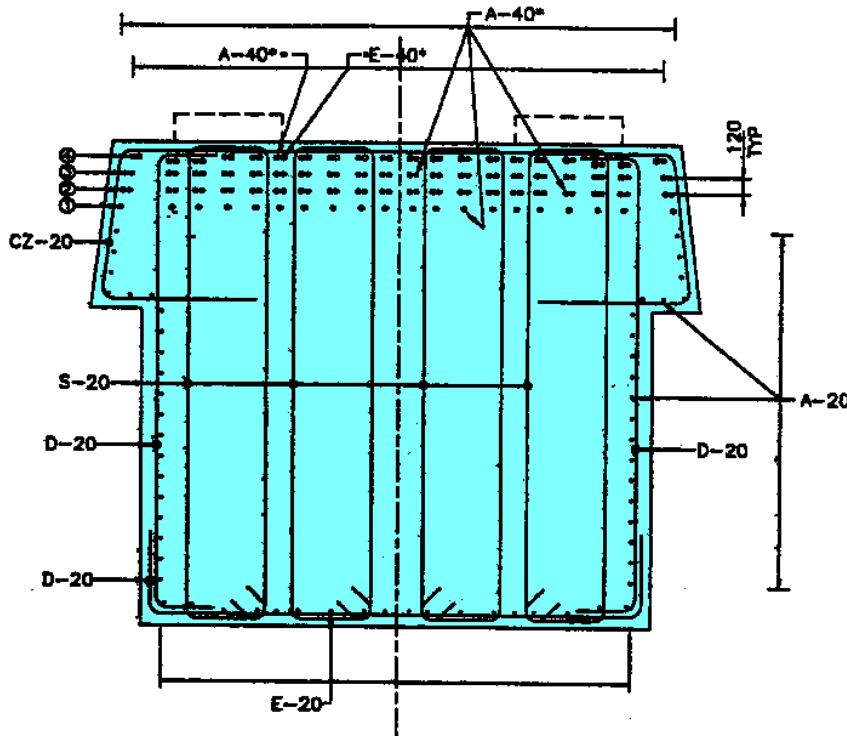
**Original Design T20@150mm**

- Alternative design did not provide adequate transverse steel in the crosshead;
- Alternative design T16@175mm (replaced T20@150mm in the original design) was inadequate in resisting tension in the crosshead.
- This failure to take up transverse tension had caused splitting during erection of the box girders.
- The design calculations should have taken into account all loads including the crane loads during erection.
- The calculations for transverse steel in the alternative design and the consultant's assessment of the cracks were grossly missing.

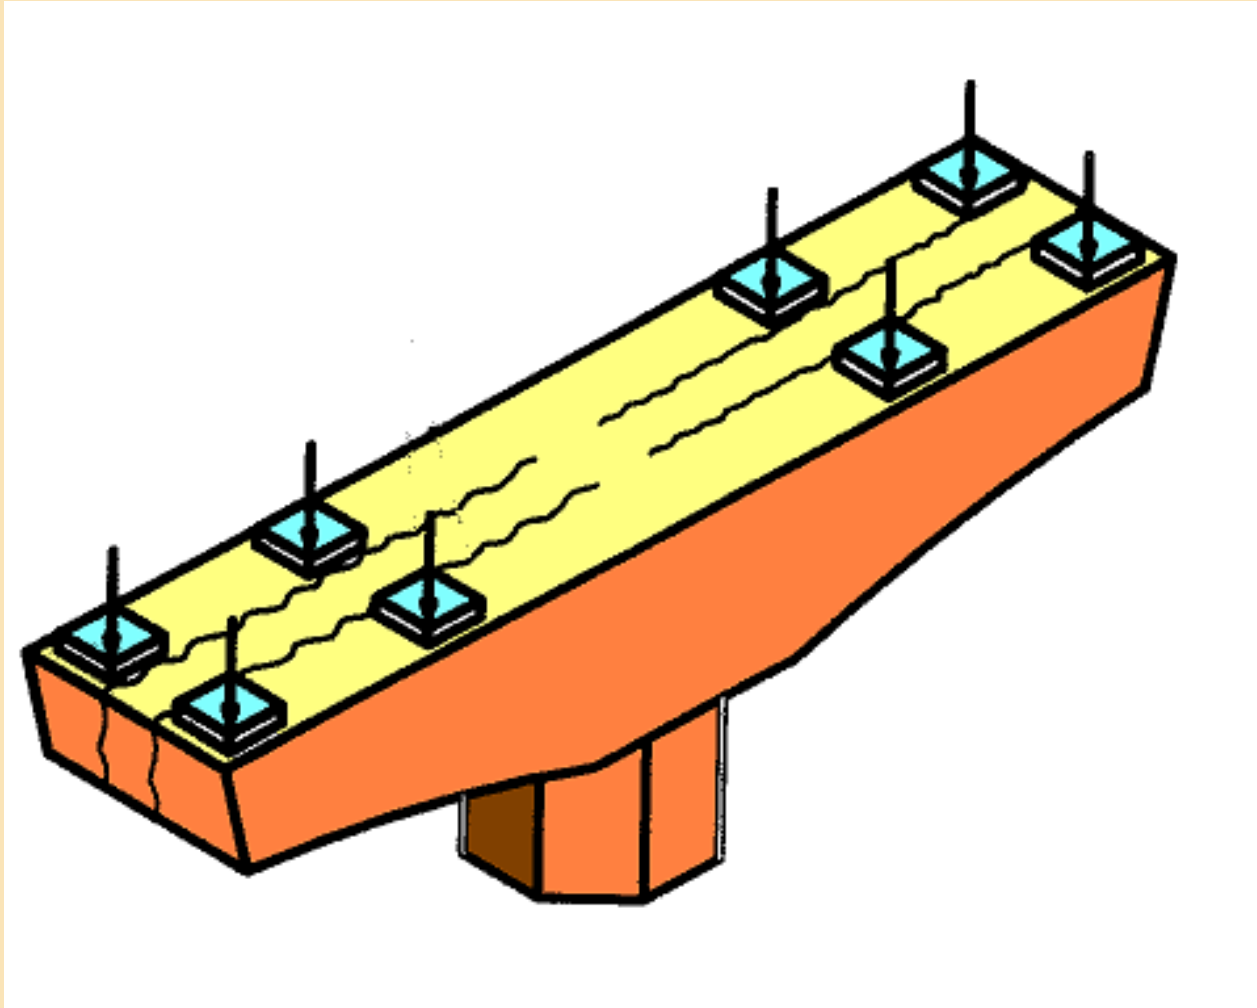
# Splitting due to Transverse Tension

- Structural cracks – splitting of concrete.
- Inadequate transverse steel to take up tension.
- Cannot take up dead load (SW) plus crane during erection.
- No design calculations for transverse tensile force consideration.
- Factor of safety based on transverse tension is less than 1.
